CASE STUDY

Wares Creek Dredging Project Bradenton, Florida, USA	
Flint Industries TITANTube®	
Owner: Manatee County	
Consultants:	U.S. Army Corps of Engineers
Contractor:	Transwest Dredge
Construction:	2011 - 2012

Dewatering Geotextile Tubes

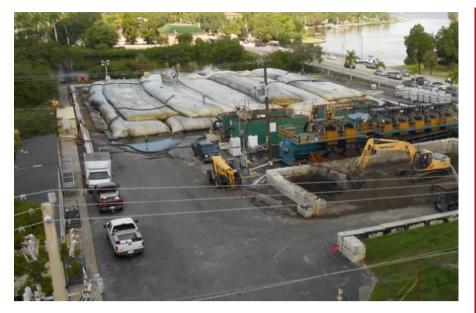
Main picture: Aerial View of Dewatering lot

The dewatering operation was designed to process 1.7 million gallons of water a day from the creek. Sand and silt was dredged from the creek and sent through an array of filtration systems. A lot adjacent to the 32-foot dredge held the heavy equipment designed to carry out the process. Sediment from the dredge was put into a separation tank which started the purifying process. Huge hydrocyclones took the material from the creek and vibrated it through very fine screens to separate the solids from the water.

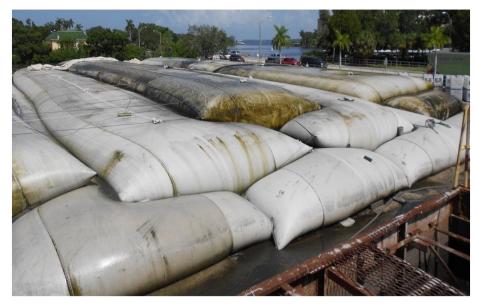
Left: TITANTube® geotextile tubes

Above: Pumping the sediment into the TITANTube® dewatering geotextile tubes

TITANTubes® are easy to install and utilise. The tube is lined with either pallets, geonet or a more permanent drainage media. If needed a polymer mix is fed into the sludge stream. The sludge is then pumped into the tube via the fill port on top and the water flows through the pores of the fabric while solids are retained. When the tube is full of dewatered material the solids can be recovered or taken for disposal. The TITANTube® is composed of high-tenacity polypropylene yarns which are woven into a network in such a manner that the yarns retain their relative position to each other for the high demands required.
