## CASE STUDY

# OK Tedi In-Pit Crusher Upgrade

Reinforced Earth Walls  
TerraMet®

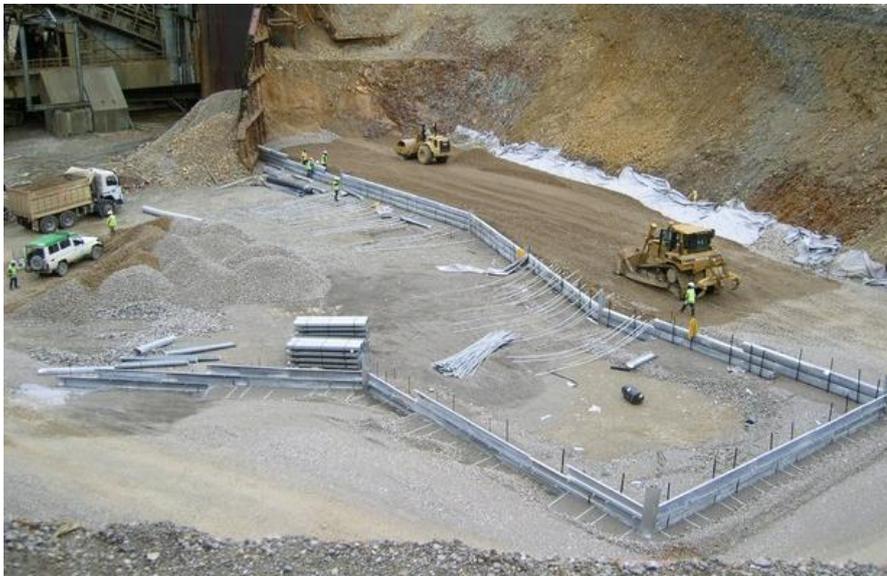
Main Picture: Construction of TerraMet® dump structure begins. Note panels and strips stockpiled on site, and grader and bulldozer spreading and compacting backfill, respectively.

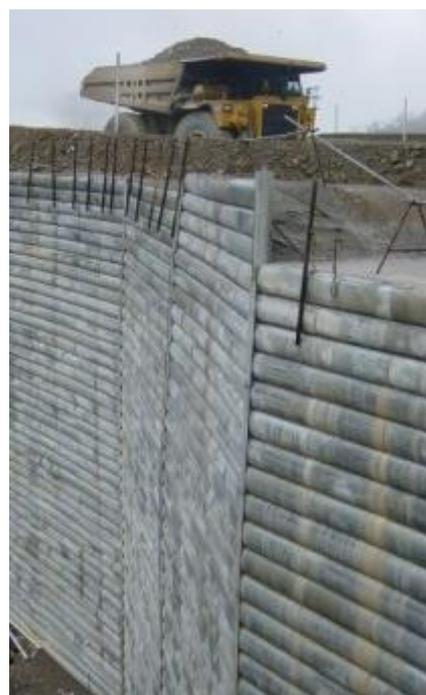
Top: Mine vehicle on top of structure. Above: Spreading select fill on top of REhas® reinforcing strips.

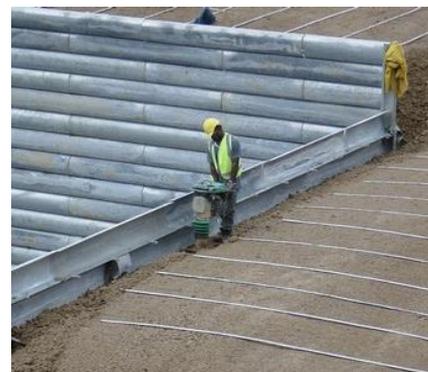
Above: Hand compacting backfill near face of structure.
